## **Hyperion Treatment Plant**

ROV Inspection

## **One-Mile Diversion Chambers**

Report Date: October 25, 2021

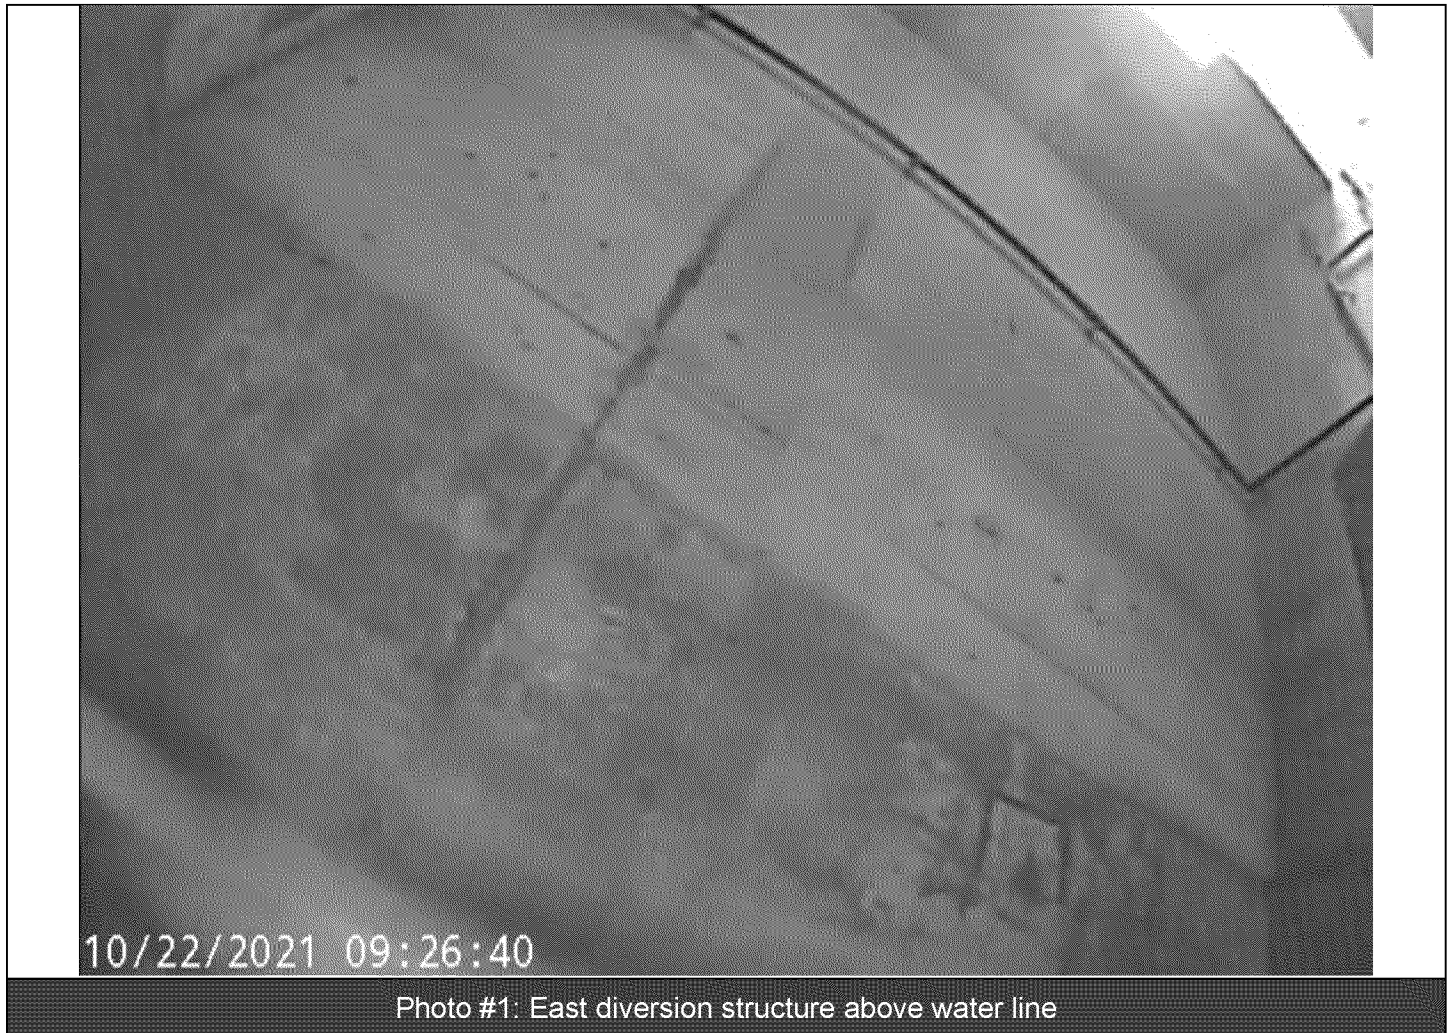
Overall, the condition of the diversion structures was clean, and the water clarity allowed for a thorough inspection of the structure both above and below the waterline. There were no observed indications of structural issues or concerns inside of the diversion structures. The gates appeared to be clean and free of obstructions. There was a very thin layer of sedimentation on the bottom of the structure, but it is not a concern at this time, and it would not have obscured structural defects if any were present.

The diversion structures had some floating debris that appeared to be from storm drains nearby. In the photos and video files provided with this report a majority of what is seen floating in the water is broken up leaves/organic material and minor sediment. The ROV found and removed several small pieces of plastic.

Based on the observed condition of the Diversion and Surge Chambers, Ballard Marine Construction recommends performing periodic inspections to ensure trash from storm drains are removed.
